The Martian Landscape

By The Viking Lander Imaging Team

Scientific and Technical Information Office
NATIONAL AERONAUTICS AND SPACE ADMINISTRATION
Washington, D.C. 1978

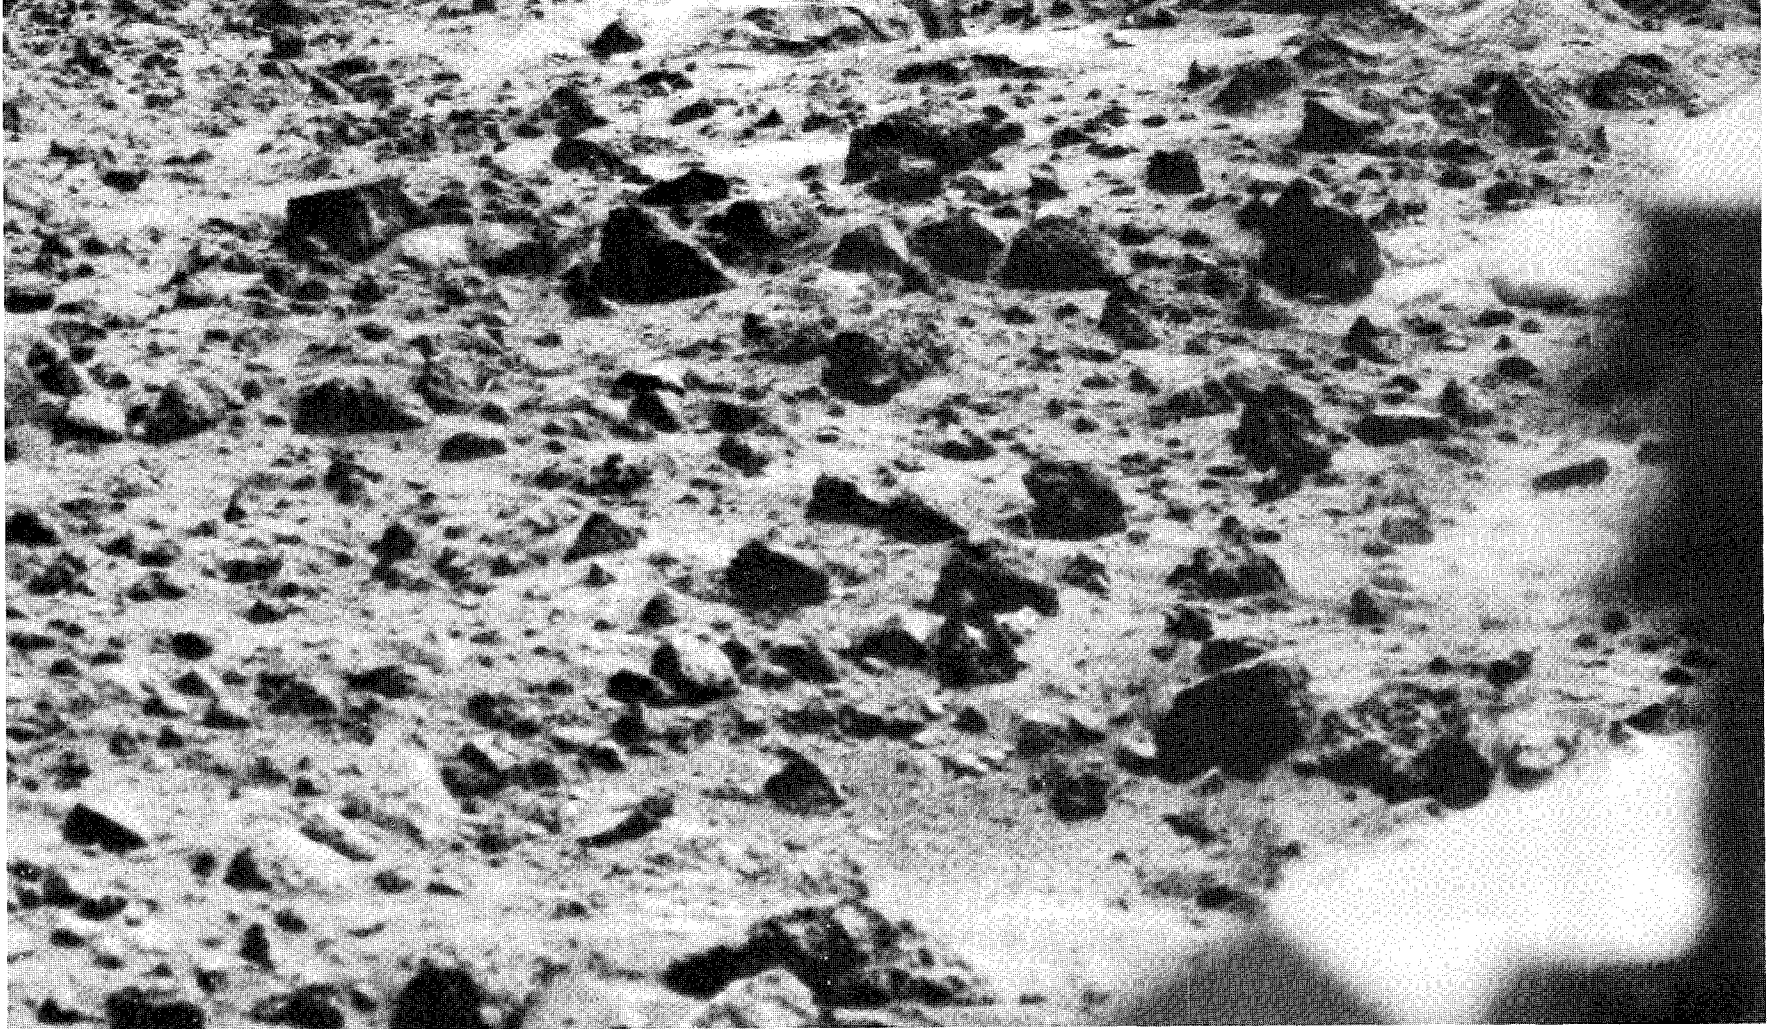
FIGURE 42

More blocks! Figures 42 and 43 show the same scene under different lighting conditions: afternoon backlighting in figure 42 and morning frontlighting in figure 43. A low-gain antenna used to receive commands sent from Earth to Mars is visible in the lower right. This receiver failed shortly after landing, one of the very few component failures on the spacecraft. Subsequently, all commands were received through the dish-shaped high-gain antenna mounted at the rear of the spacecraft.

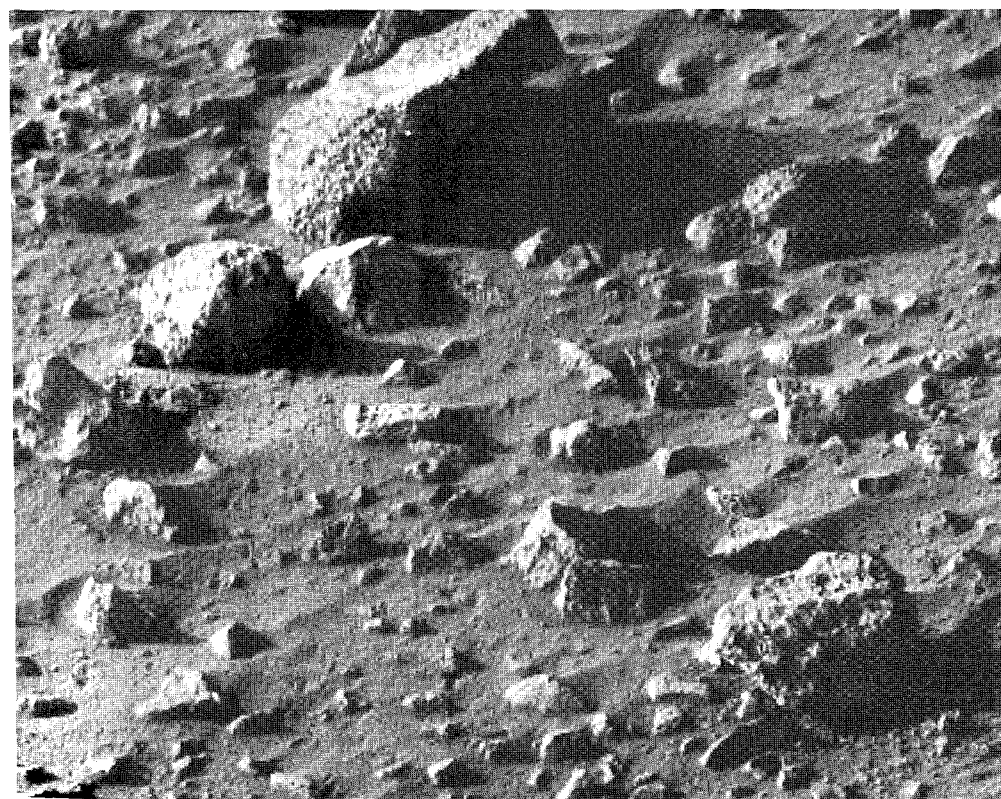
FIGURE 44

Figures 44 and 45 show the same scene with low and high Sun illumination. The large block in the upper center, like many other blocks throughout the scene, appears to be coarsely granular. This type of

block may be derived from igneous rock that crystallized at shallow depth within the crust where cooling rates were slow enough to allow growth of large crystals. The pitted appearance is a result of preferential erosion around these grains by wind-blown dust.

Many of the blocks seen here, and in previous figures, have fillets of fine-grained sediment preferentially arranged in one direction. These "tails" probably were formed as the prevailing wind transported fine particles. Eroded from exposed regions, the particles were preferentially deposited in the protected lee of boulders. Alternatively, some of the tails may be protected remnants of a dust cover that originally covered the blocks.

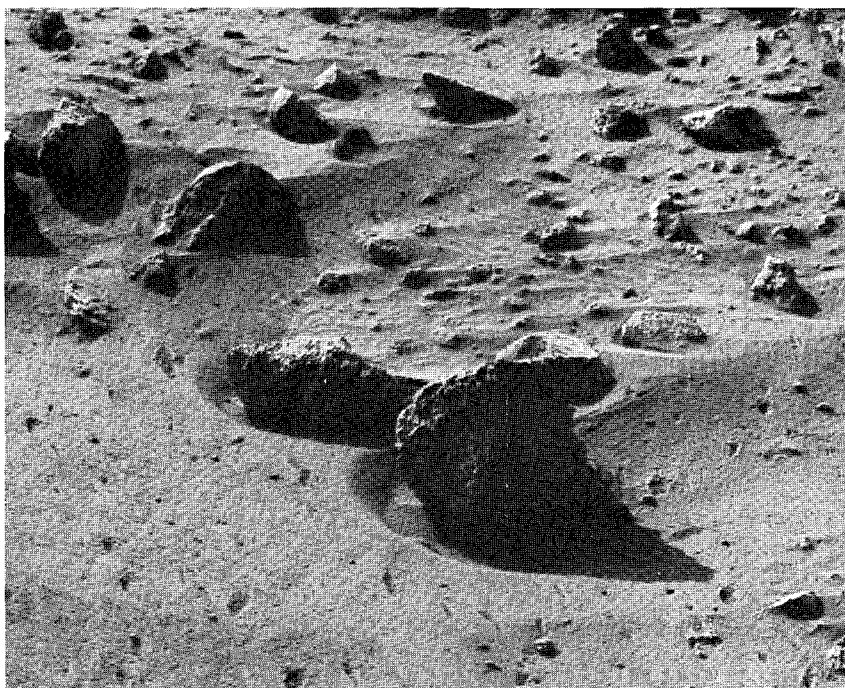
FIGURE 46

Figures 46 and 47 graphically illustrate how the appearance of the scene changes with differing illumination. Erosional depressions around blocks are clearly shown in figure 46, although little can be deciphered regarding the configuration or texture of the blocks themselves. Figure 47 shows structure on the block in the foreground that has earned it the nickname "Sponge Rock." This distinctive texture must be telling us something. But what? Without actually picking up the rock, examining it with a hand lens or under a microscope—common geological techniques on Earth—it is difficult to make a unique determination. For example, it has been suggested that the darker spots are dark clasts in a lighter groundmass. The texture, then, would be that of a breccia, a fragmental

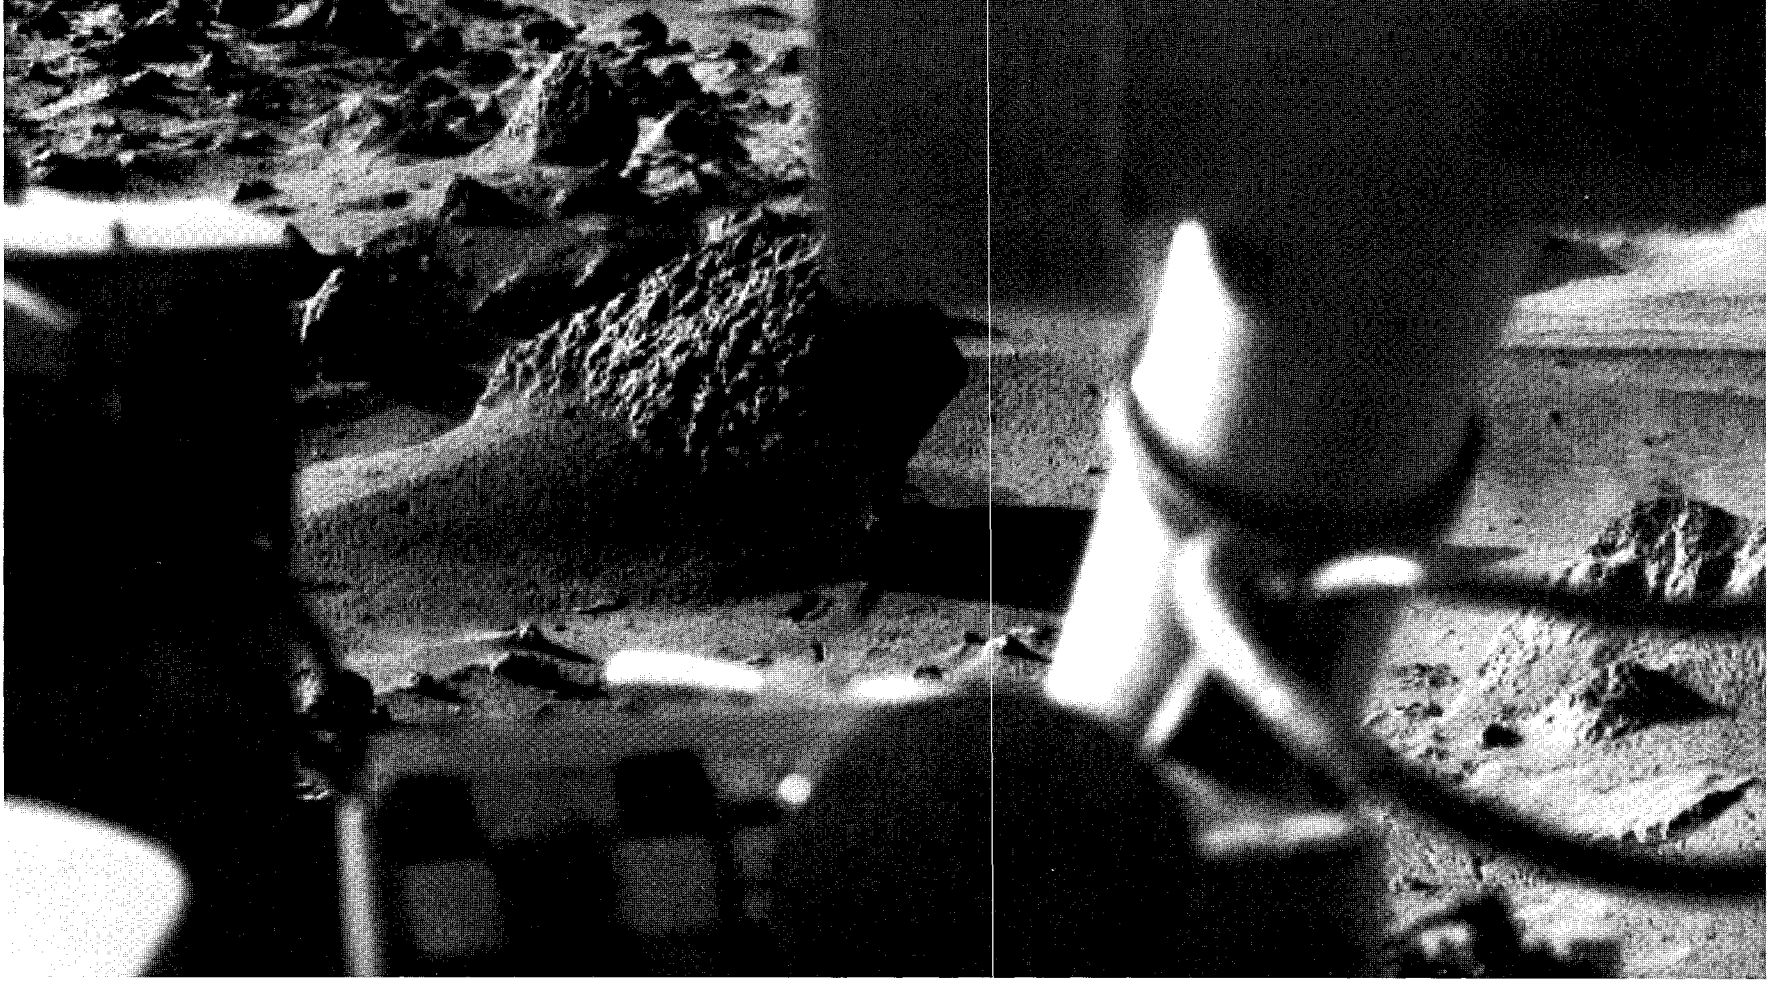
FIGURE 48

Figures 48 and 49 are two views of the same area, looking back across the space-

craft. The prominent structure on the right is the supporting mast for the S-band antenna. Nicely framed by obscuring parts of the spacecraft is a coarsely pitted block, partly buried by sediment. The sediment may represent a large wind tail similar to smaller deposits of sediment that occur in the lee of many small blocks photographed in front of the spacecraft.

The upper part of the strut assembly for the leg at the rear of the spacecraft appears at the left of figures 48 and 49. Note the striped rod which measures the amount of compression in the landing shock absorber, roughly analogous to an extended, indexed rod in an air-pressure gauge for tires.

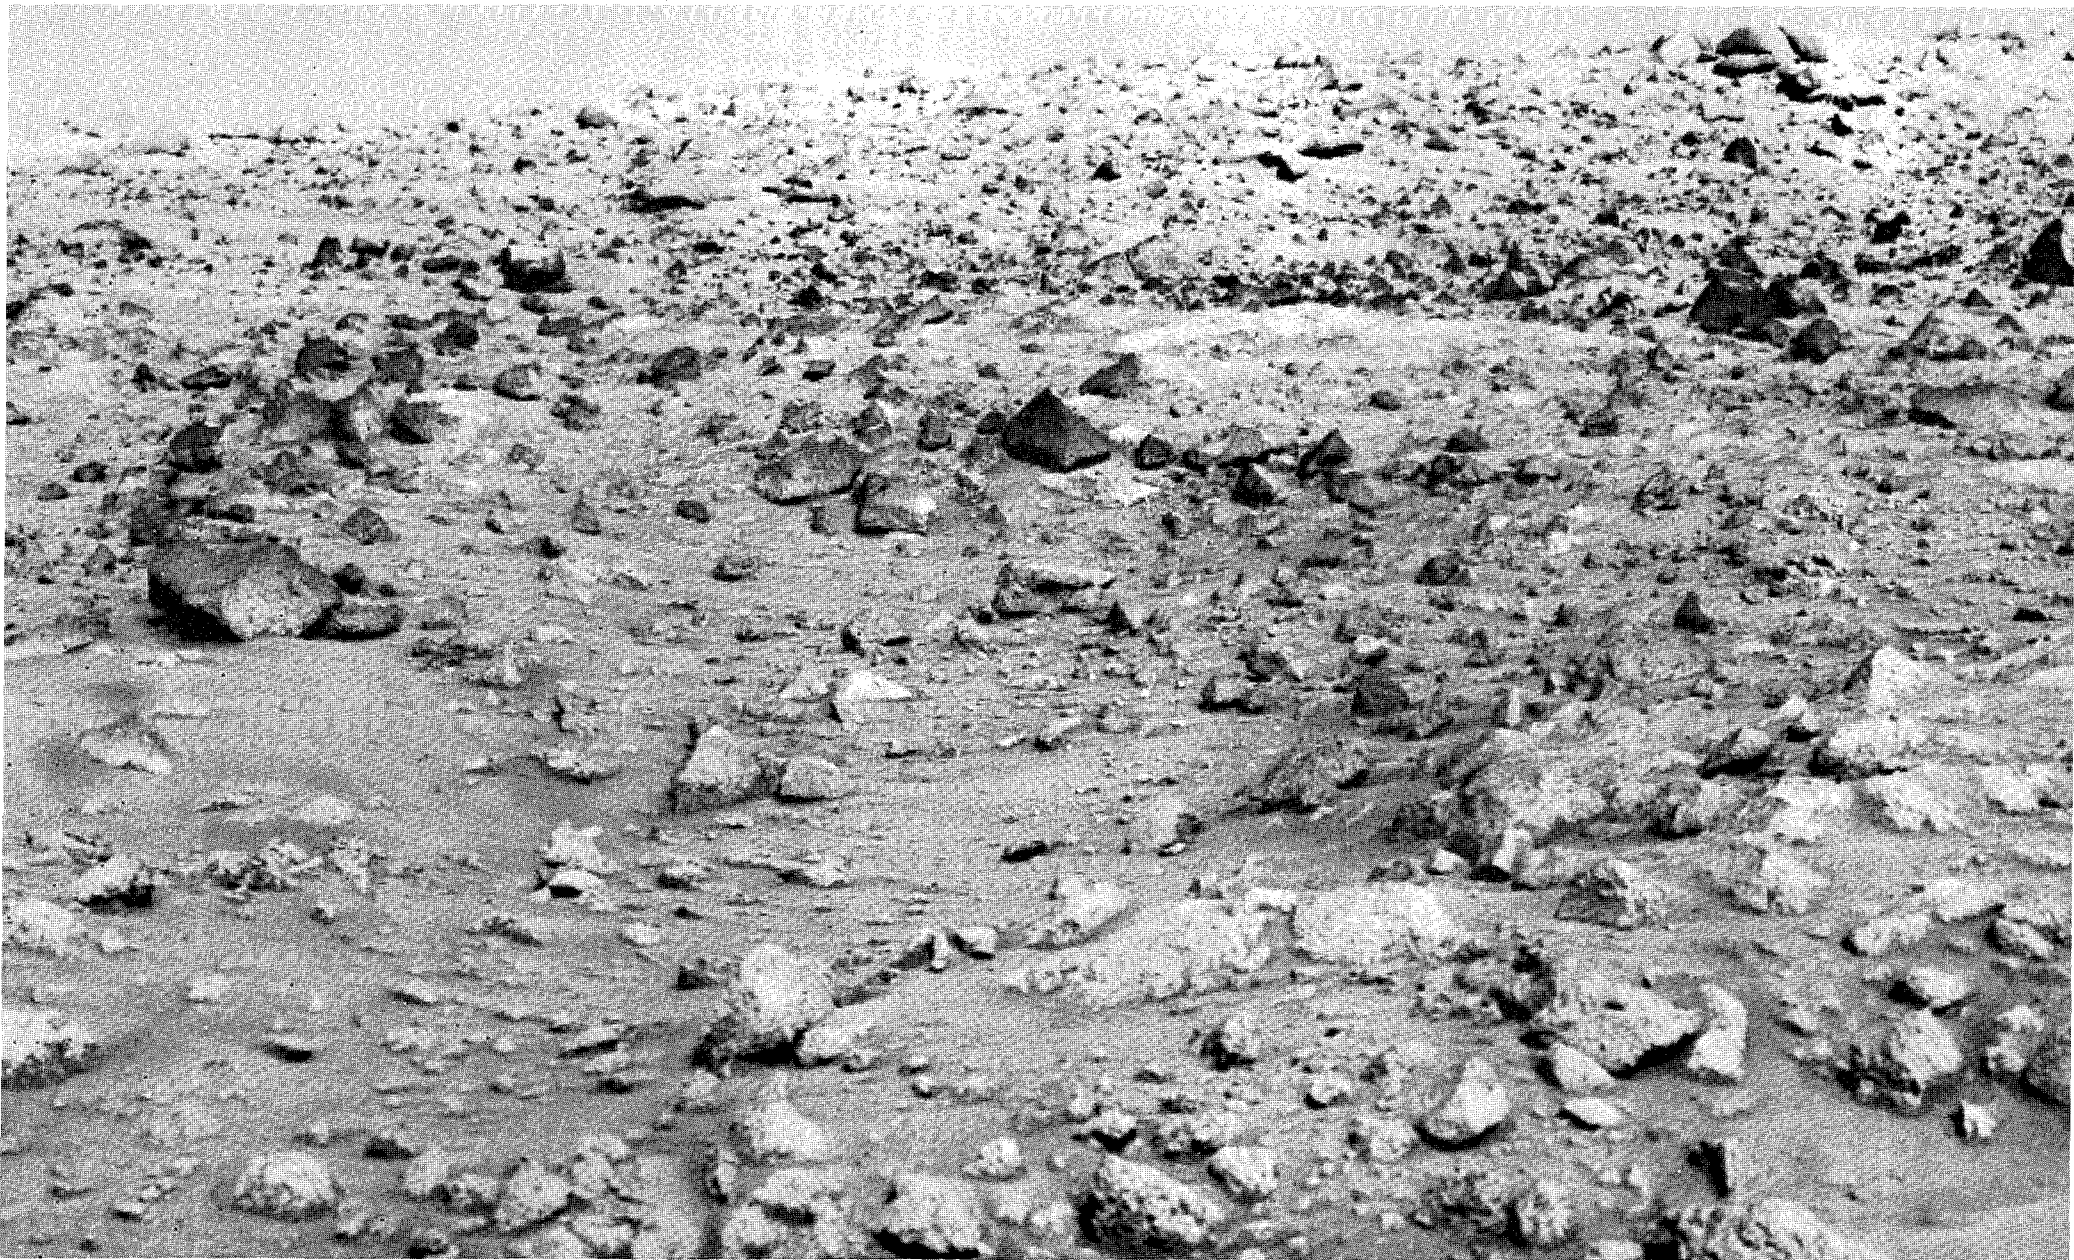
FIGURE 50

The diversity of rock types of the Viking 1 landing site has been a matter of controversy. Some geologists argue that only one or two fundamental rock types are represented, and that the diversity of block shape and size is attributable to erosion. Other geologists claim to see ten or more fundamentally different rock types, indicating igneous rocks of varying chemical composition crystallizing under varying conditions. Figure 50

shows a variation in block type that is beyond dispute. In the midfield there is a group of dark boulders that contrast with the brighter boulders elsewhere in the scene. Figure 51 is an enlargement of part of the scene showing the characteristically pyramidal shape of the dark blocks. Multifaceted blocks of this type commonly occur in terrestrial deserts. They are termed ventifacts, literally "made by the wind." Prevailing winds sandblast

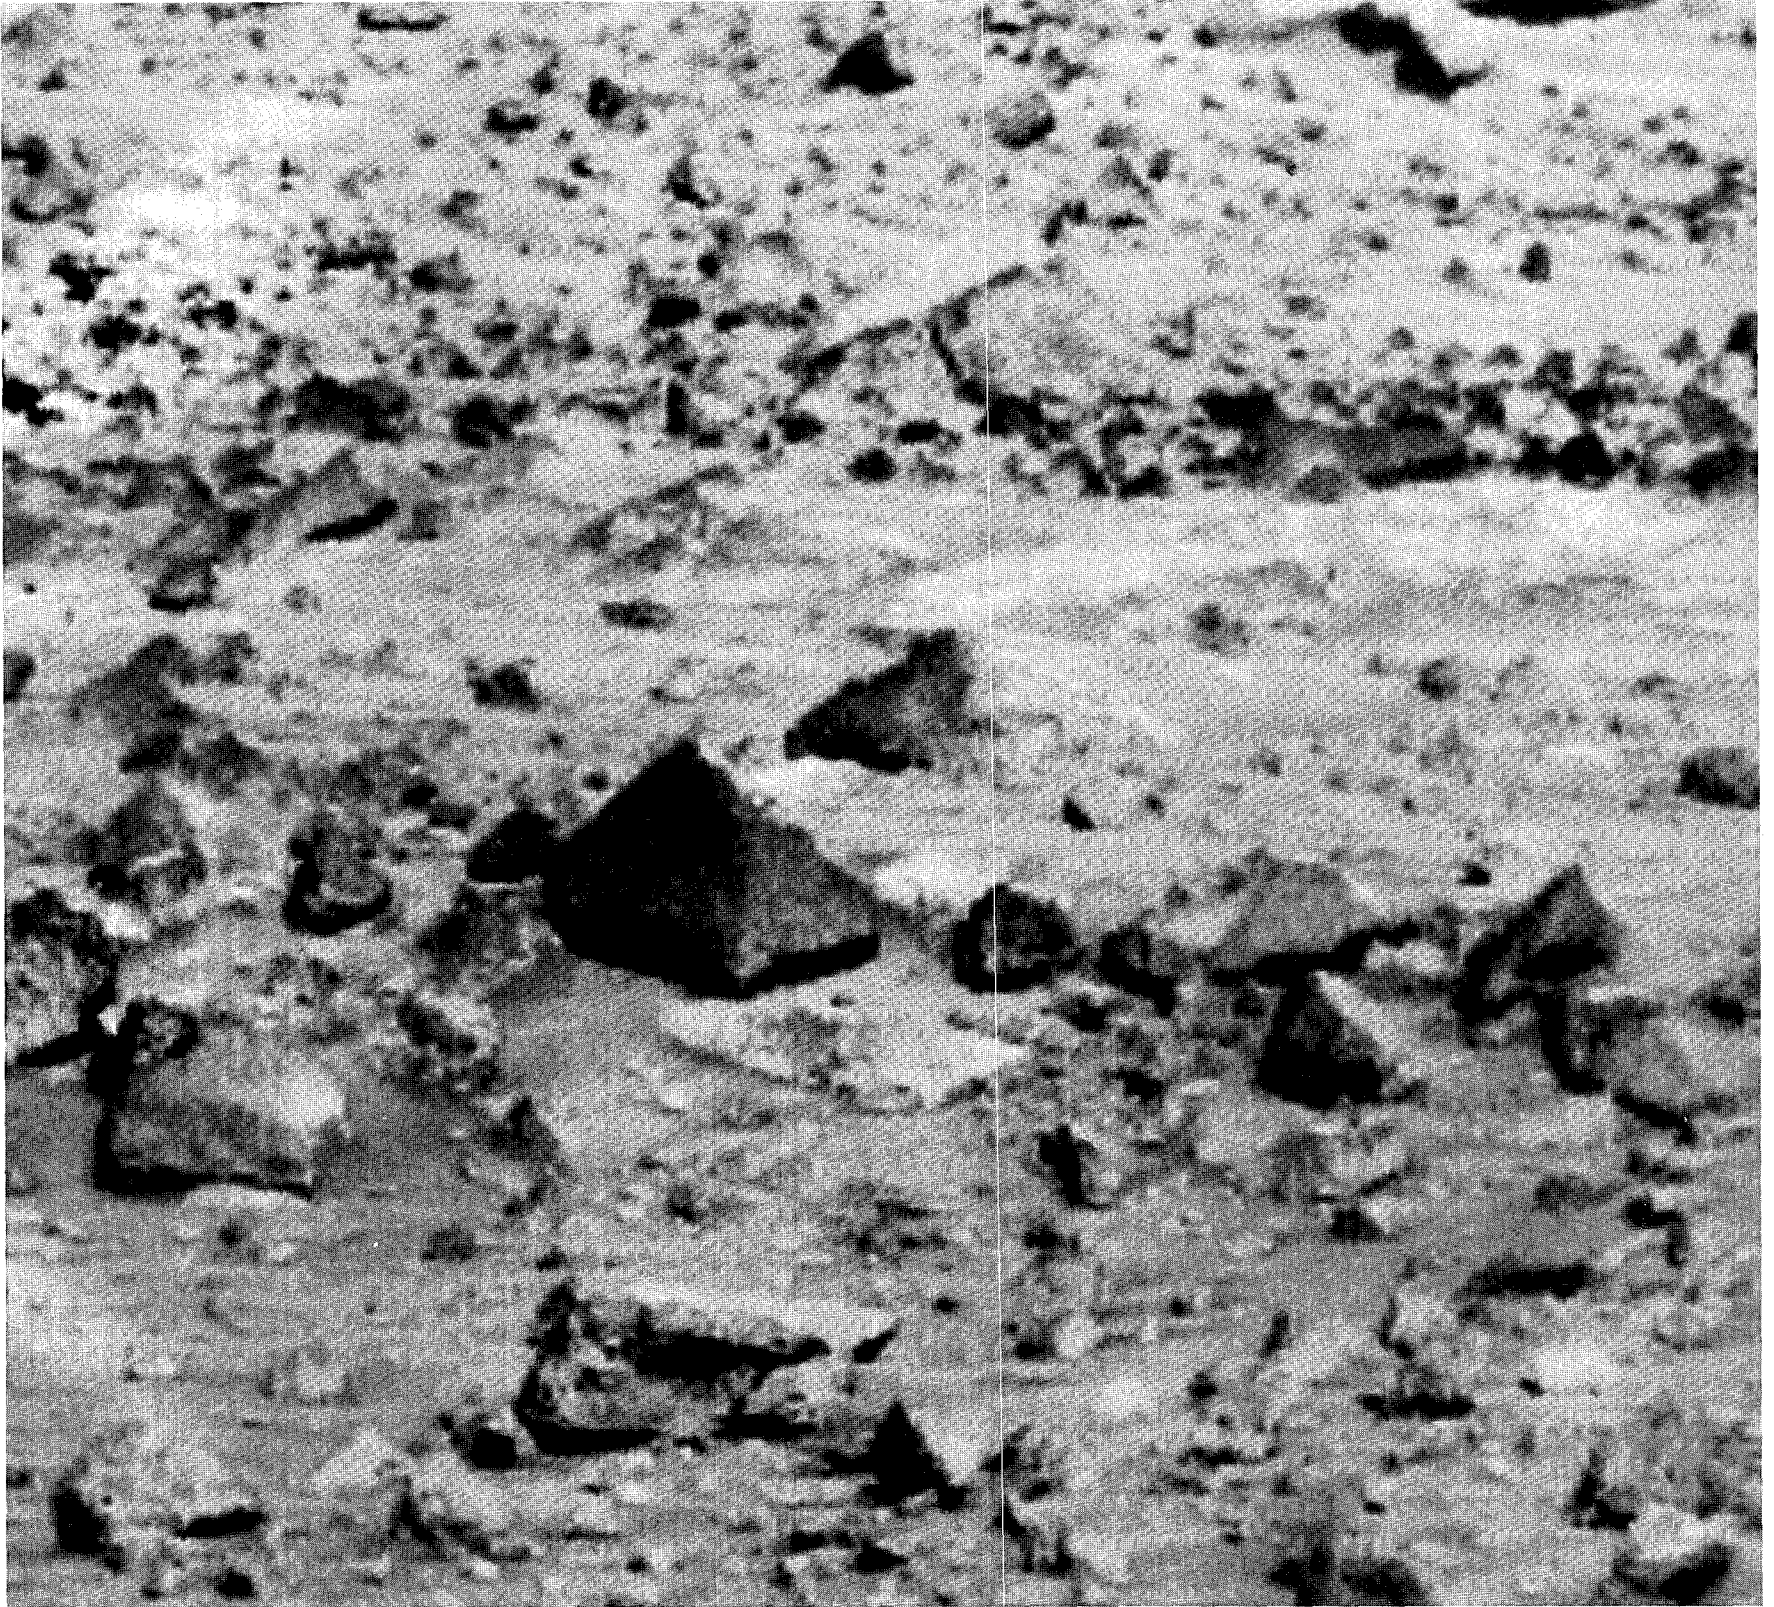
FIGURE 51

one face. Then either the block or wind shifts to create another face. The planar perfection of ventifacts depends on grain size. Fine-grained rocks such as basalt produce unusually well-formed ventifacts. Coarse-grained rocks such as granite tend to yield irregularly pock-marked faces. It is probable, then, that the dark, faceted martian blocks are wind-shaped boulders of basalt.

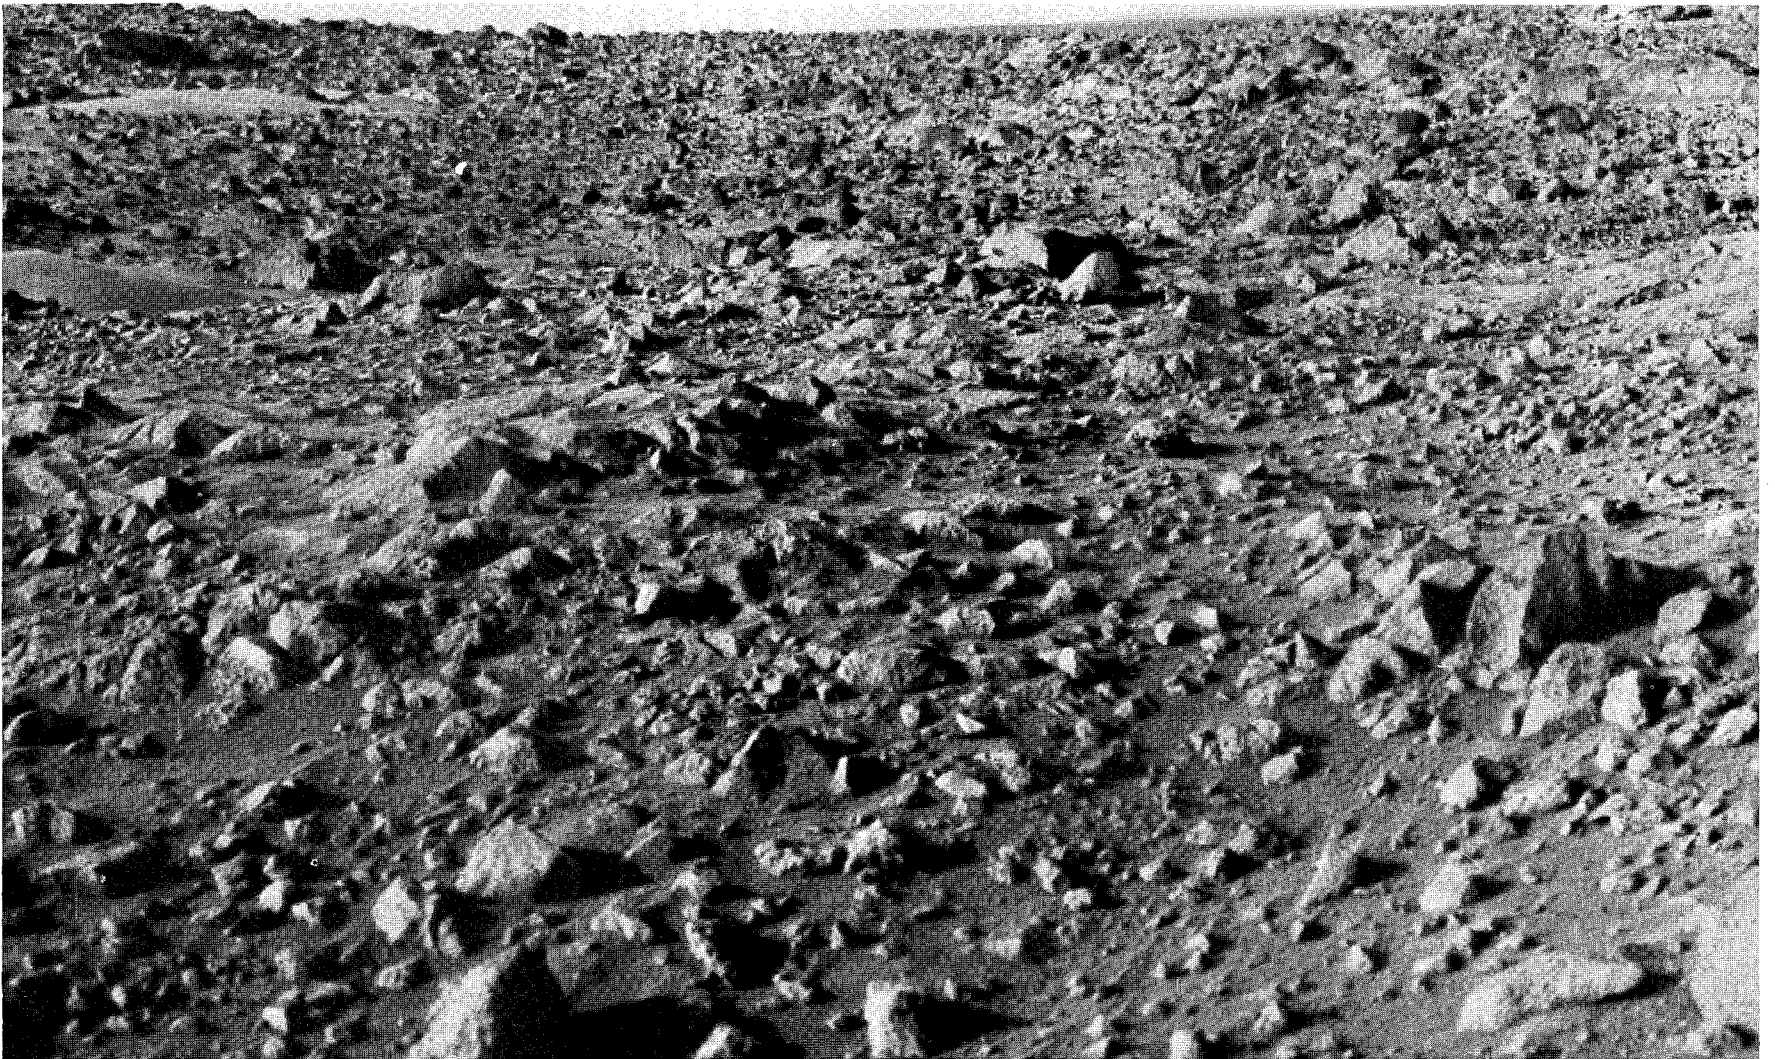
FIGURE 52

Figures 52 and 53 show a knobby exposure of bedrock broken by vertical fractures. Some of the protuberances are so deeply eroded that they almost form detached boulders. Indeed, we believe that many of the boulders at this site form by this mechanism of *in situ* weathering.

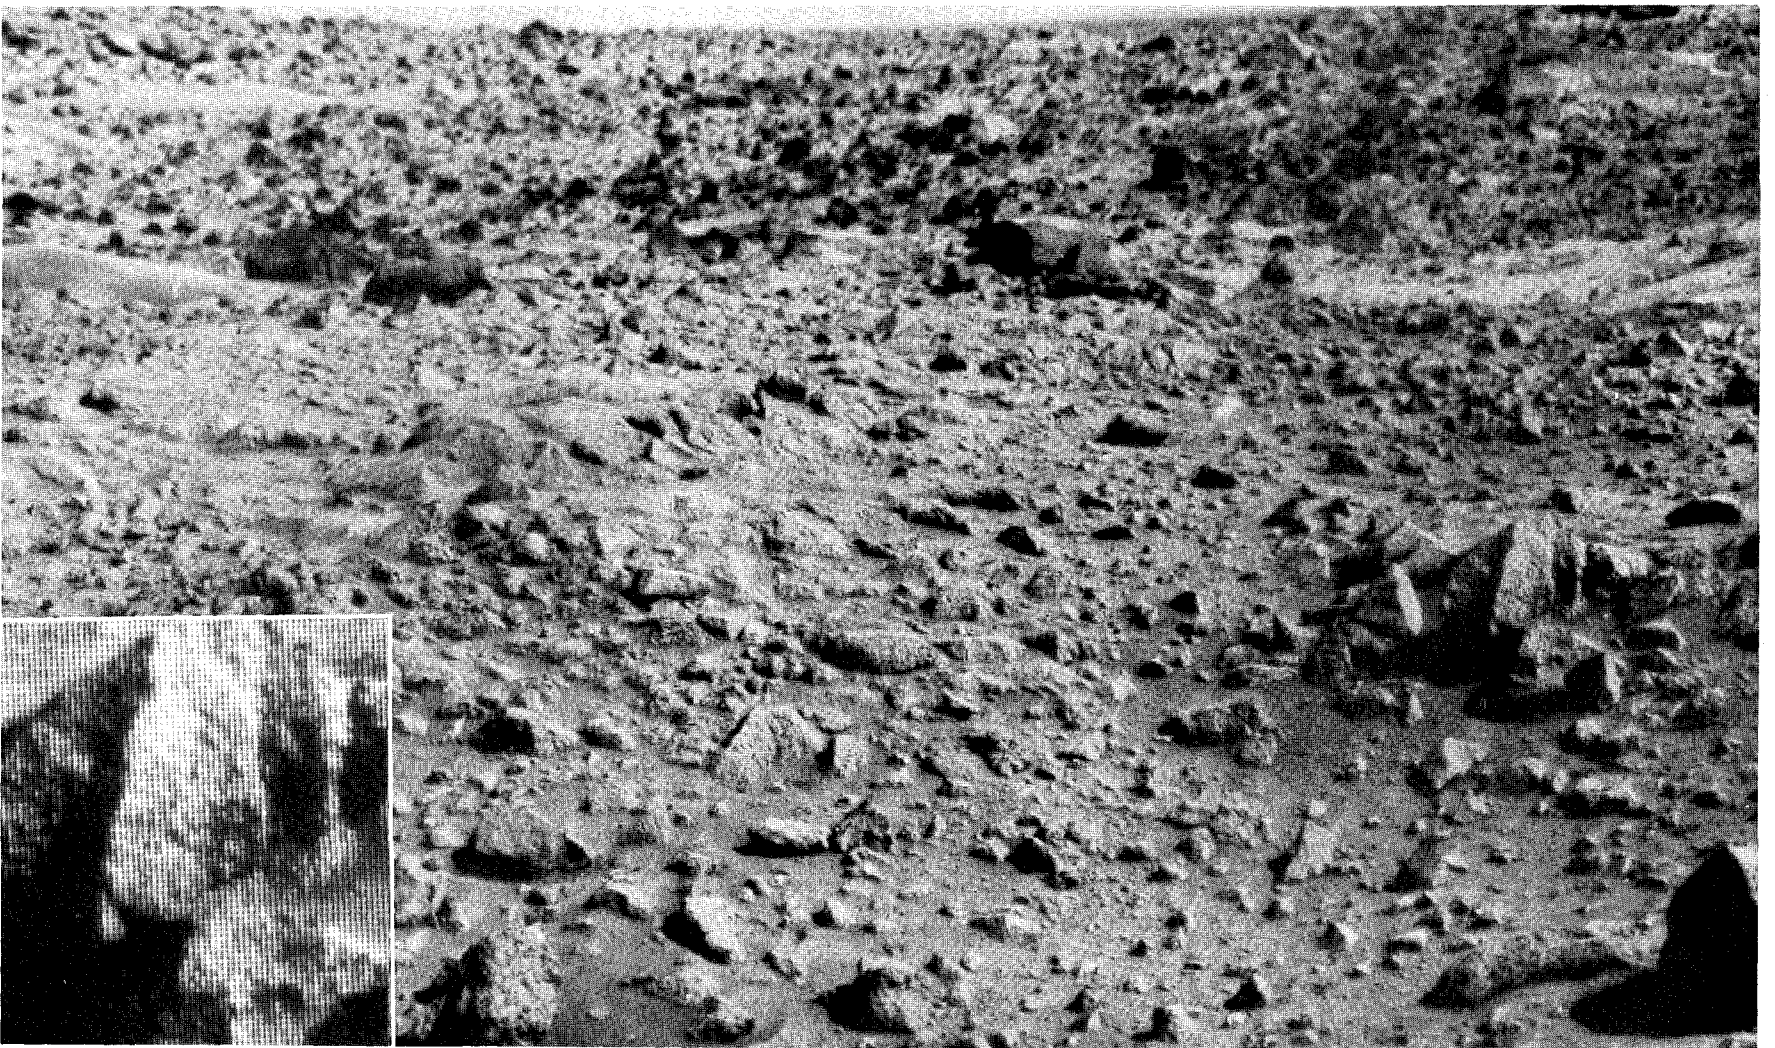
FIGURE 53

At the right edge of figure 53 is a block with a marking that, generously interpreted, is the letter "B." An enlargement of the same block is shown in an inset.

This block was first photographed approximately five days after landing. The marking elicited no comment from scientists, but one of the media representatives excitedly reported graffiti on Mars. A press conference was hastily arranged, at which time geologists explained that there are many surface markings and erosional stains on rocks that superficially resemble organized symbols. No doubt, some viewers with vivid imaginations remain unconvinced.

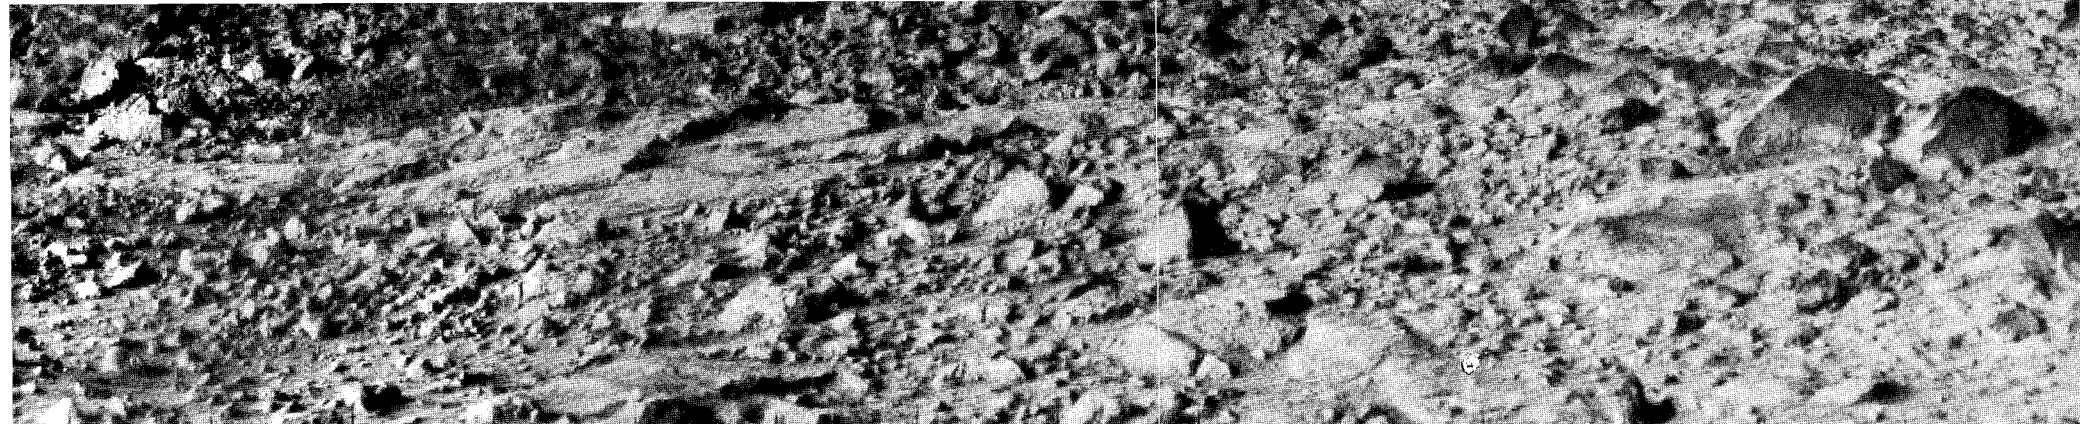
FIGURE 54

The area of bedrock in figures 54 and 55 is more clearly delineated. Horizontal

rock surfaces have been swept clear of sediment. The fact that this rock weathers in a different fashion than the rock displayed in figures 52 and 53 suggests a compositional difference between the two exposures of bedrock. Both rock types are believed to be representative of volcanic lavas that inundated the entire region early in martian history.

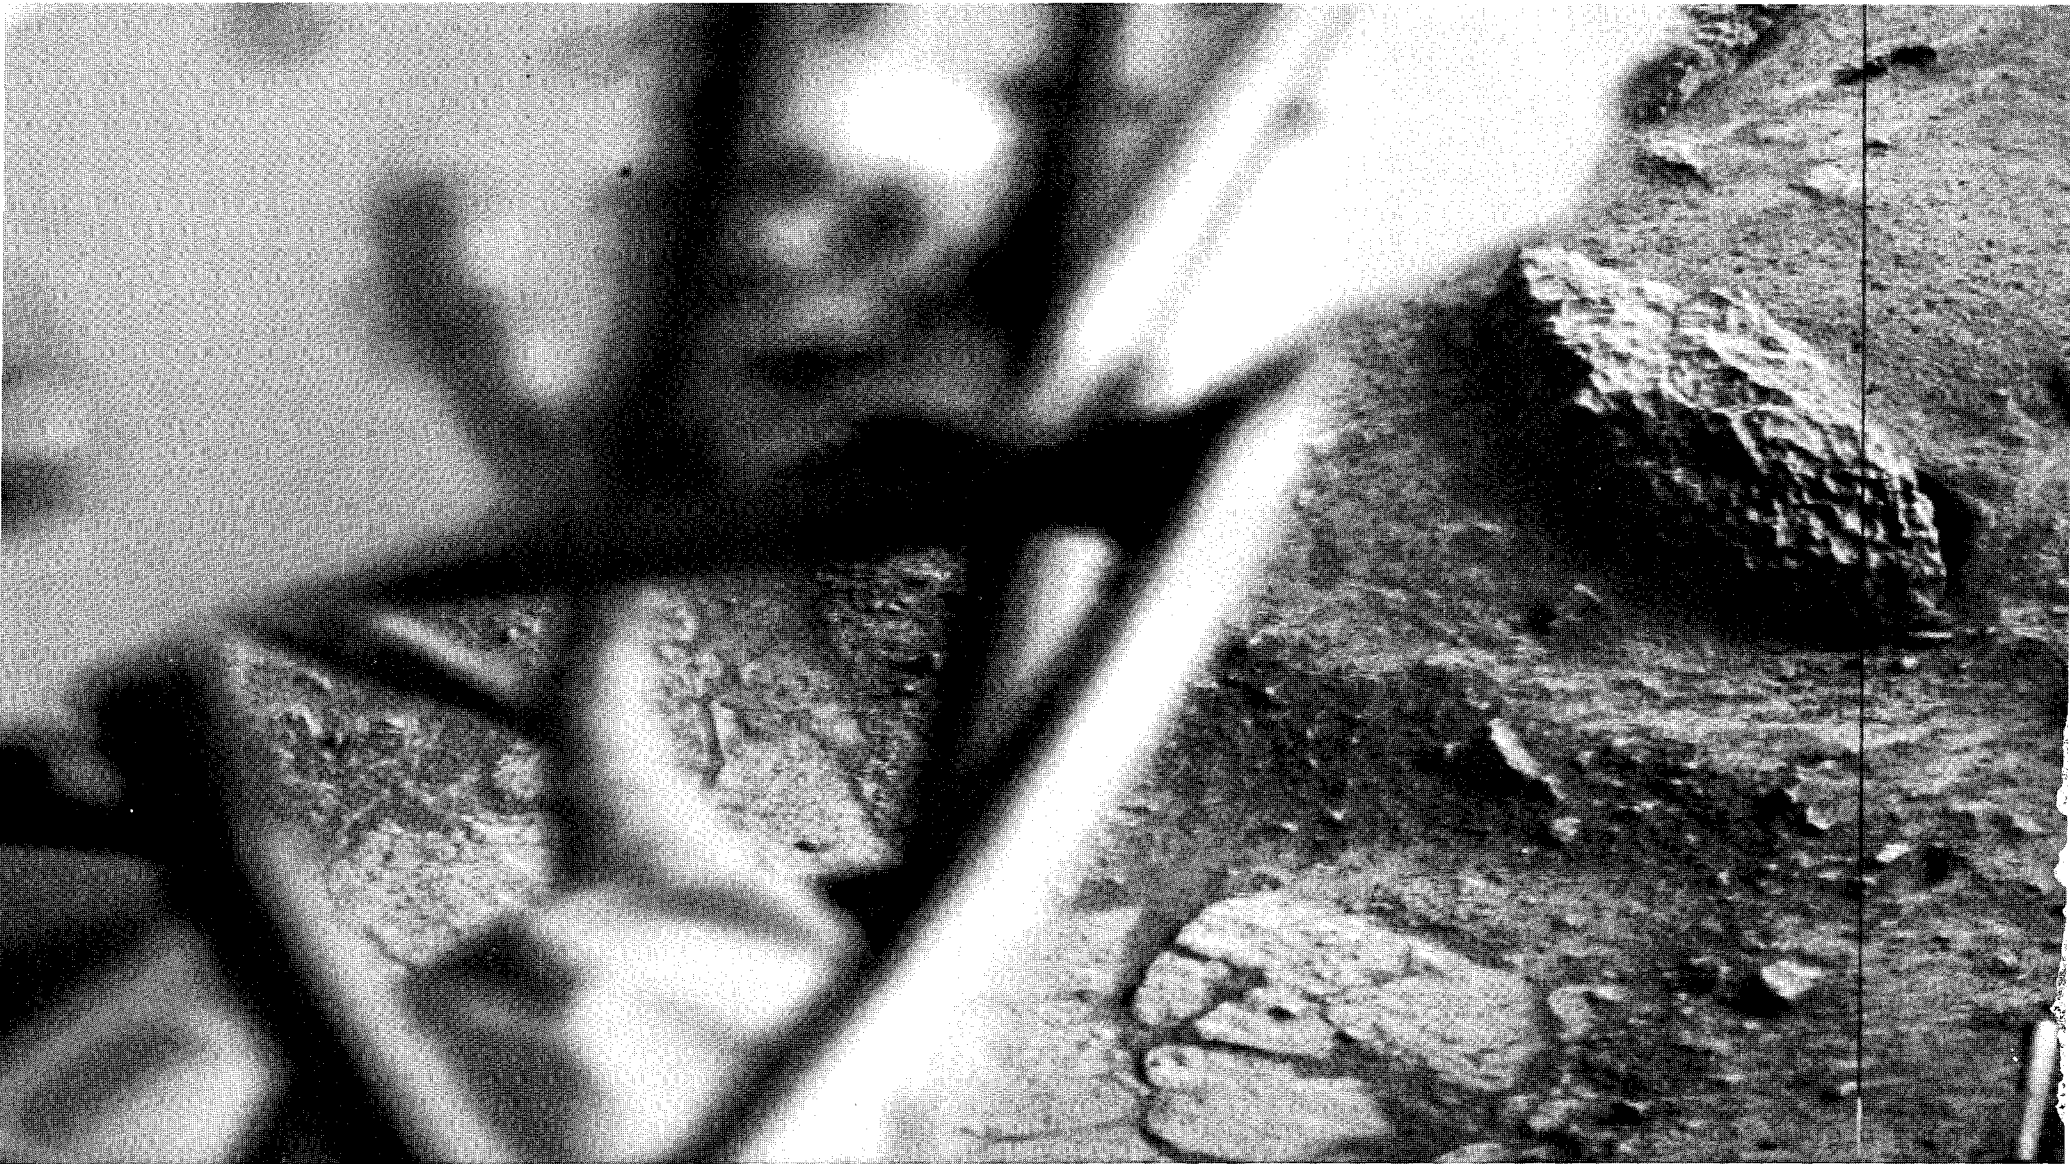
FIGURE 56

Although the Viking 1 landing was very gentle, examination of subsequent pictures revealed more and more signs of surface alteration at the time of landing. Many of the changes were due to the exhaust of the three small retrorockets mounted one on each side of the triangular Lander body. Figure 56 shows, on the left, an area beneath the retrorocket mounted between the two cameras. A region of flat, indurated, cracked material has apparently been swept clear of overlying sediment. Similar dried and mudcracked layers occur in arid regions of Earth where they are sometimes referred to as hardpan or caliche. The layers are indurated by the precipitation of

A small cylindrical pin rests on the soil, about halfway across the bottom of figure 56. This is the infamous locking pin that should have been ejected from the surface sampler during its first maneuver. Because the arm was not extended

far enough the pin failed to drop to the ground, and the sampler mechanism jammed. Subsequently, when the arm was commanded to extend further, the pin finally dropped out. The proof is in this picture.

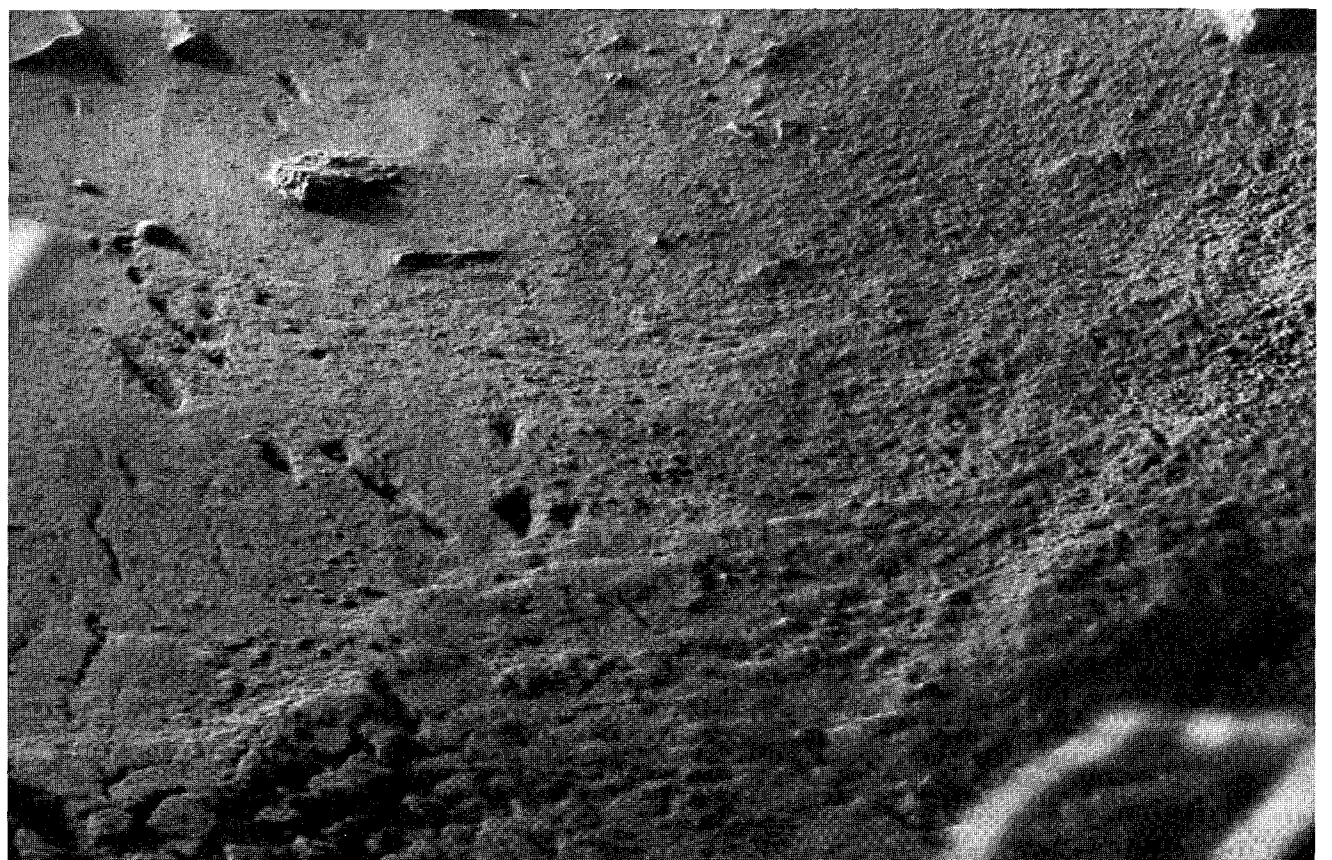
FIGURE 57

Figure 57 shows a common feature wherever fine-grained material is present. Small pebbles or pellets of soil thrown out by the force of the rocket exhaust have fallen back into fluffy sediment, creating elongate pits. This sort of feature occurs at many different scales on planetary surfaces. Some large lunar craters such as the Imbrium impact basin have secondary craters that extend over an entire lunar hemisphere.

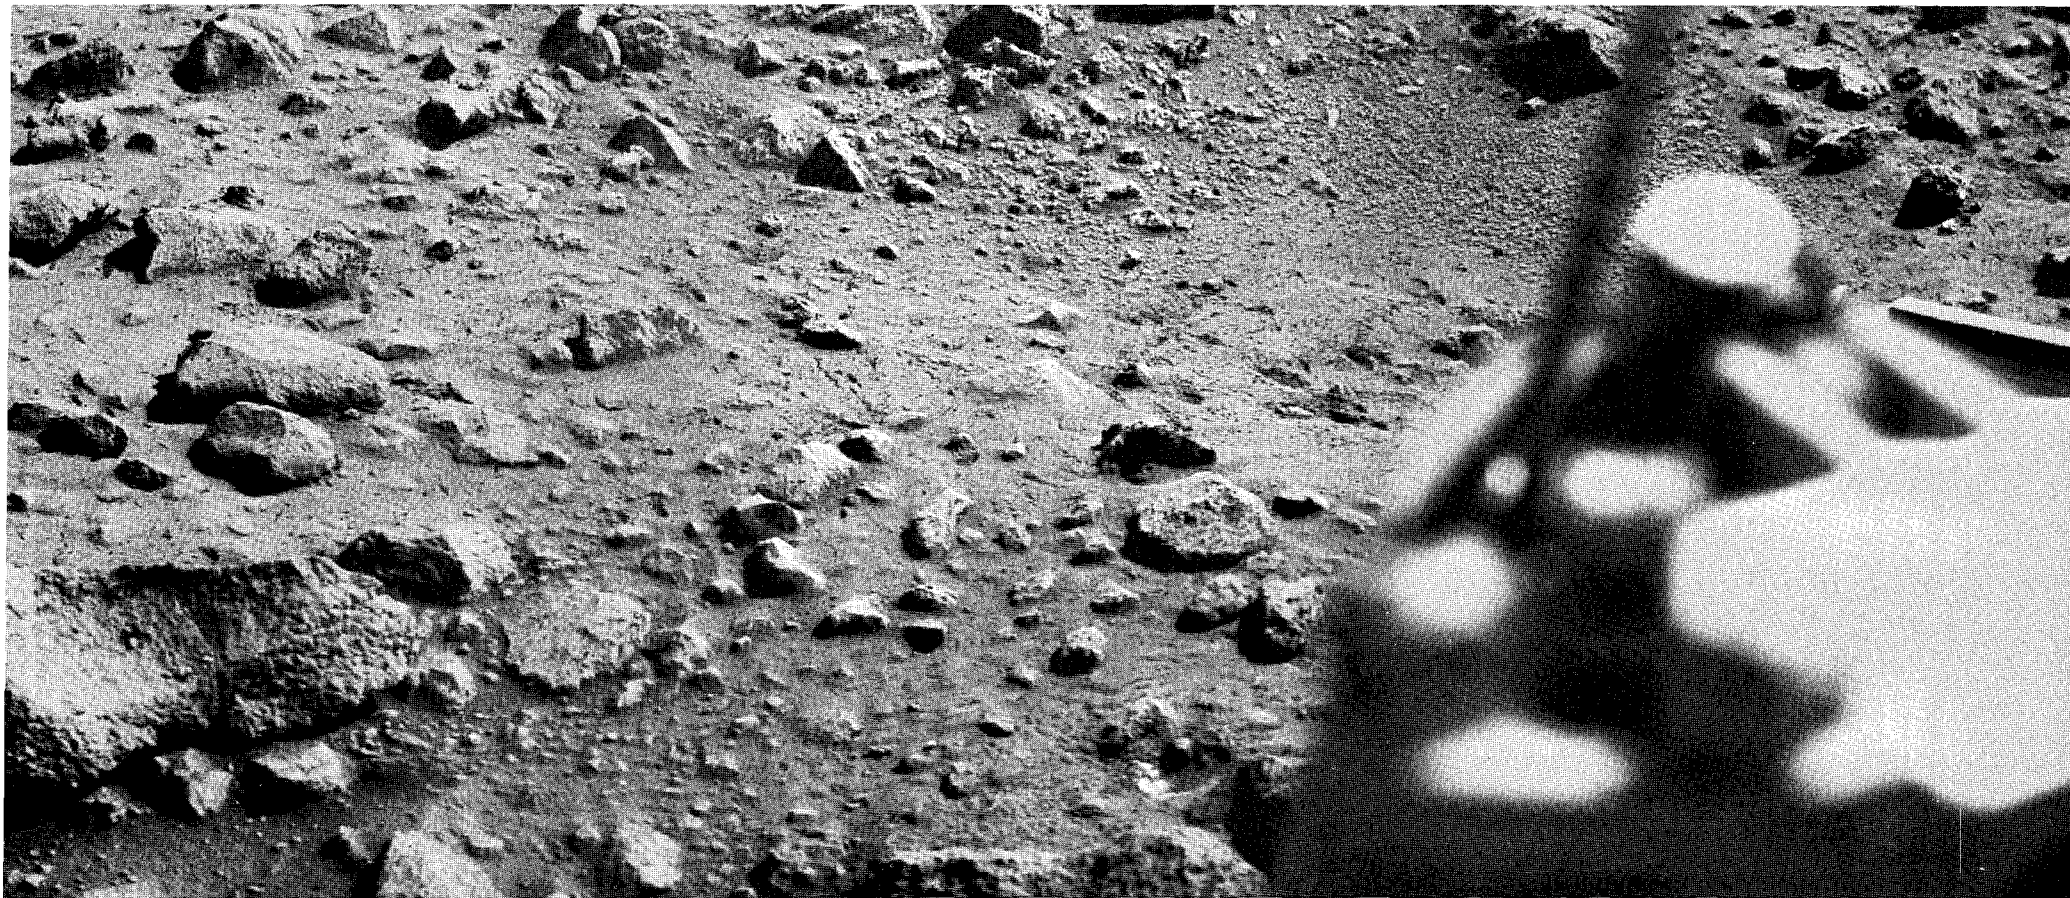
FIGURE 60

Figures 60 and 62 are two pictures of the same area taken under different lighting conditions, although figure 60 shows a larger area than does figure 62. Figure 61 is an enlargement of the area in the upper right corner of figure 60. Pits formed by throwout of soil pellets during landing rocket maneuvers are particularly well displayed in the right side of figure 62. At the far right of figure 61, just above the landing leg strut, a beer-can-shaped object is visible lying on the
